Chattel Architecture Planning & Preservation, Inc.

Memorandum

RE Golden Gate Theater, 909 S. Atlantic Boulevard, Los Angeles CA
Secretary's Standards Conformance Review

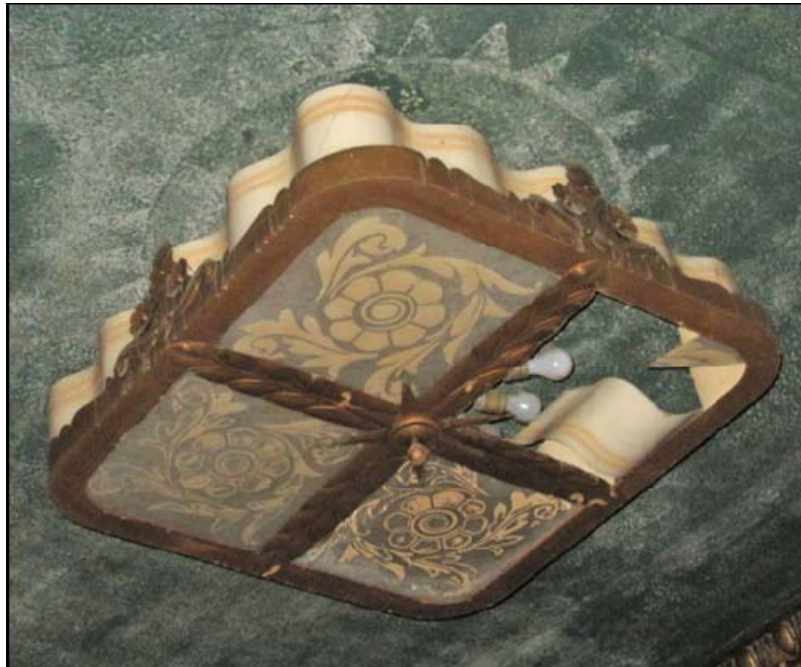
Figure 40: Golden Gate Theater, interior, detail view of ceiling-mounted lighting fixture under balcony (Chattel Architecture 2009)

- As per the project Conditions of Approval (Appendix D), historic ceiling-mounted fixtures at balcony underside will be restored and remounted to be visible from sales floor; they will be made functional if possible (sheet HPD-3.1, note 17 and sheet A-3.1). Two historic

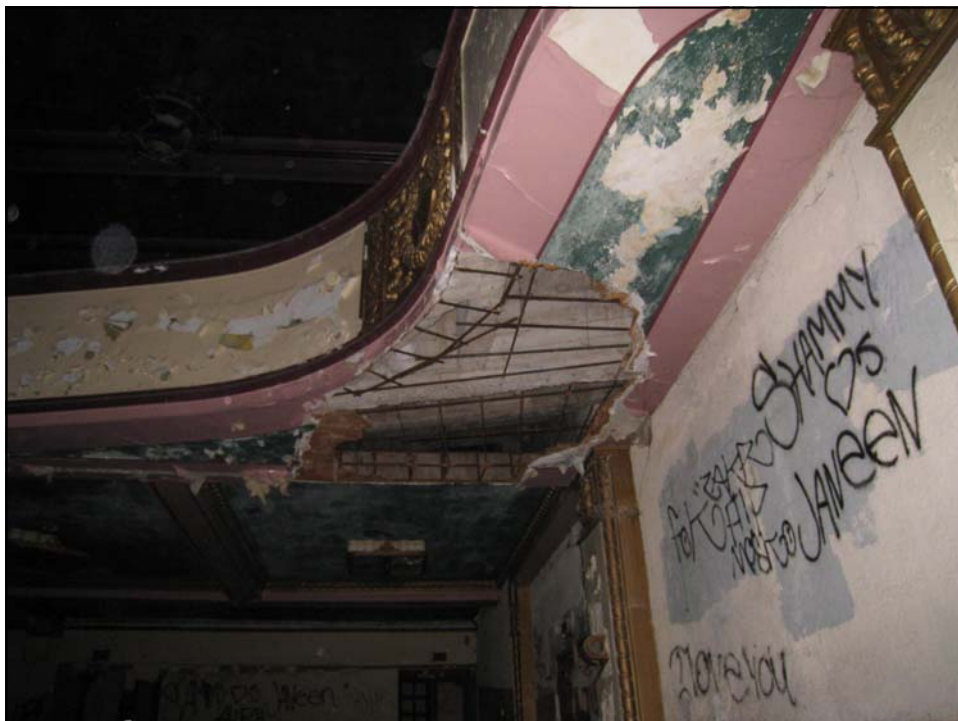
Figure 42: Golden Gate Theater, interior, view northeast showing damage to underside of balcony and leading balcony edge (Chattel Architecture 2009)

- As necessary and appropriate, existing lead based paint shall be encapsulated behind new paint layer.
- As coffered balcony underside is highly decorative and would require substantial effort to fully repair and repaint, complete conservation or restoration will not be part of the project. To repair damage and allow for preservation (stabilization) of balcony underside, damage shall be patched and infill painted as necessary.

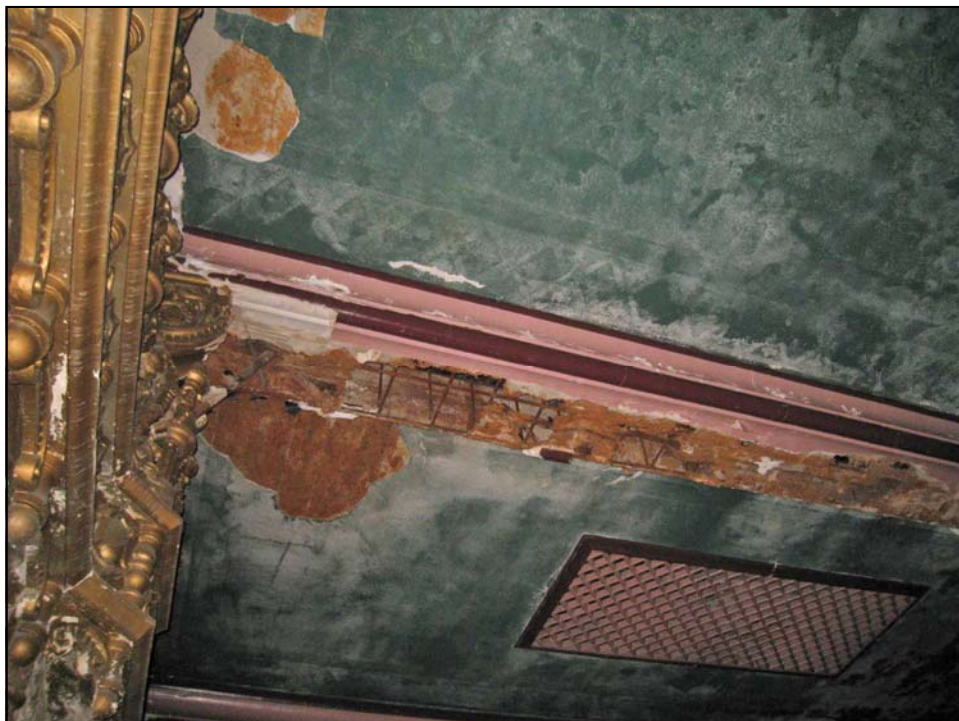
Figure 52: Golden Gate Theater, interior, detail view northwest showing ceiling and ornament damage (typical) above balcony (Chattel Architecture 2009)

- As auditorium walls and ceiling are highly decorative and would require substantial effort to fully repair and repaint, complete conservation or restoration will not be part of this project. To repair damage and allow for preservation (stabilization) of historic building fabric, damage to walls and ceiling shall be patched and infill painted as necessary. Gold-colored decorative elements will be patched and infill painted as necessary. Wall and ceiling surfaces visible from the sales floor will be painted off-white.

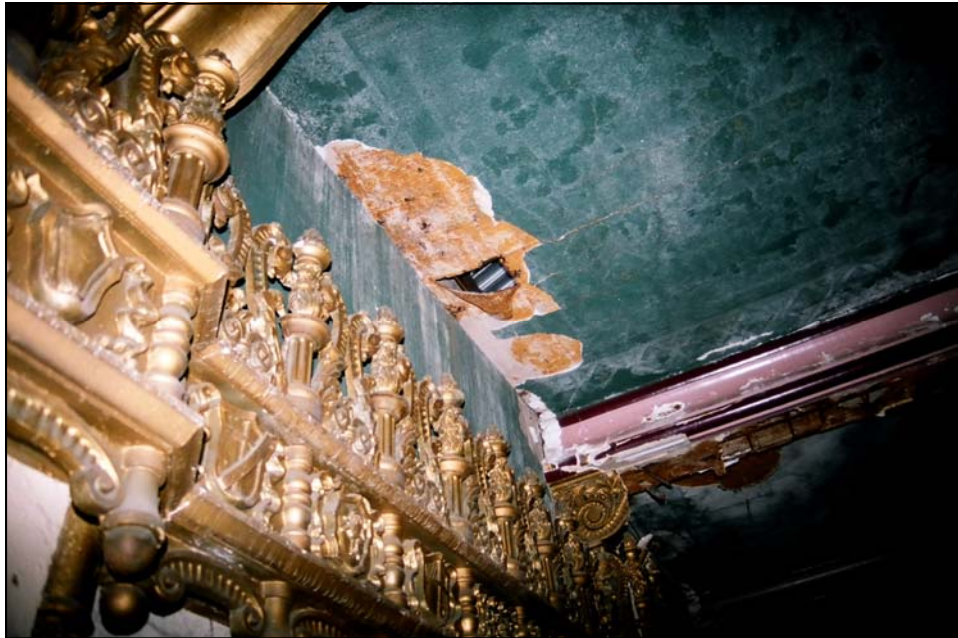
Figure 53: Golden Gate Theater, interior, detail view southeast showing ceiling and ornament damage (typical) above balcony (Chattel Architecture 2009)

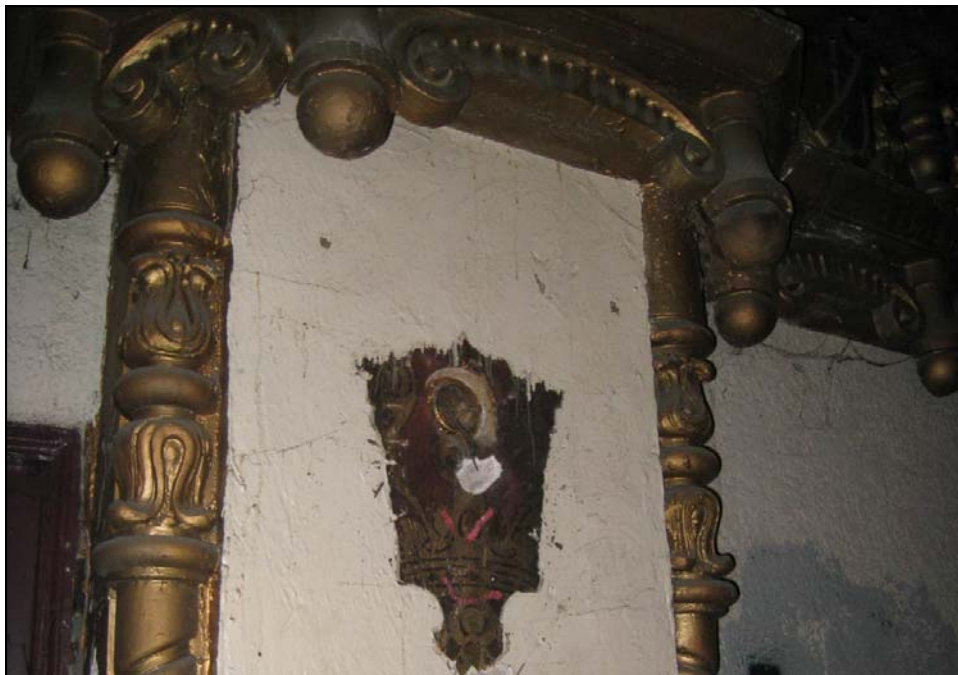
Figure 54: Golden Gate Theater, interior, detail view southwest showing wall ornament and ceiling damage (typical) above balcony; note that area of sconce removal contains polychromatic painting, indicating surfaces have been over-painted (Chattel Architecture 2009)
